by Miguel Gutierrez, OMICRON electronics, USA

Colombian Blackout 2007

The Colombian Blackout

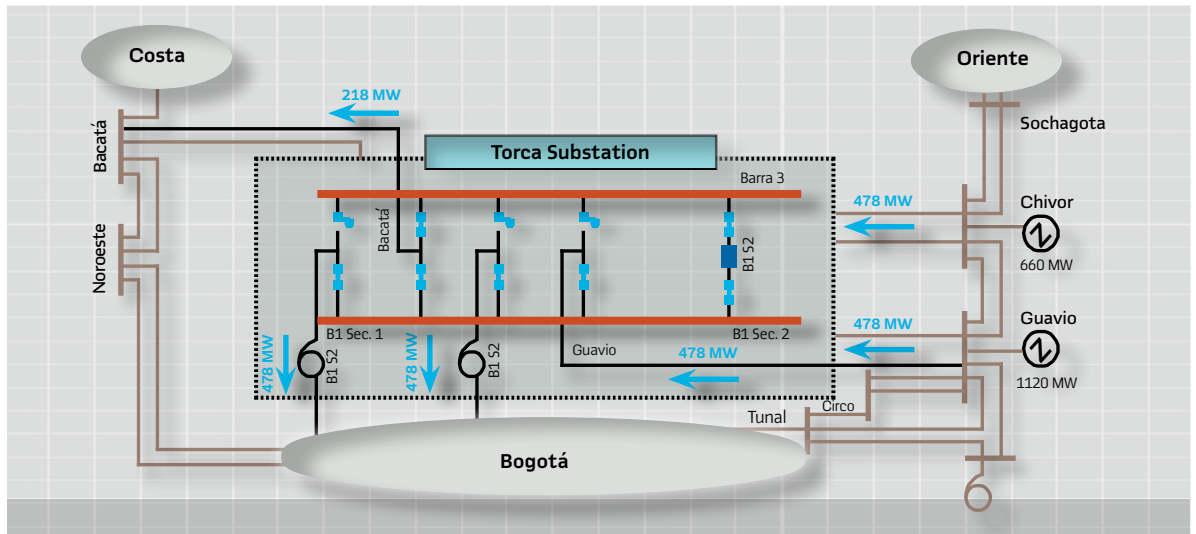
1 Torca Substation Arrangement

The Torca substation is one of the main 230 KV substations in the area surrounding the capital city of Colombia, Bogota. There is one main busbar sectionalized in two (B1 Sec. 1 and B1 Sec. 2) and a transference busbar (Barra 3) linked with a breaker, as is shown in Figure 1.

This blackout was due to human error at the 230 KV Torca substation: An operator at the substation didn't follow the correct sequence of maneuvers when transferring circuits from one busbar to another before a scheduled maintenance task in one sectionalizer. The wrong maneuver overloaded the inter-bus breaker, and breaker failure operation de-energized the whole Torca substation, igniting a cascade of events that brought down the entire Colombian Electric Power System (CEPS).

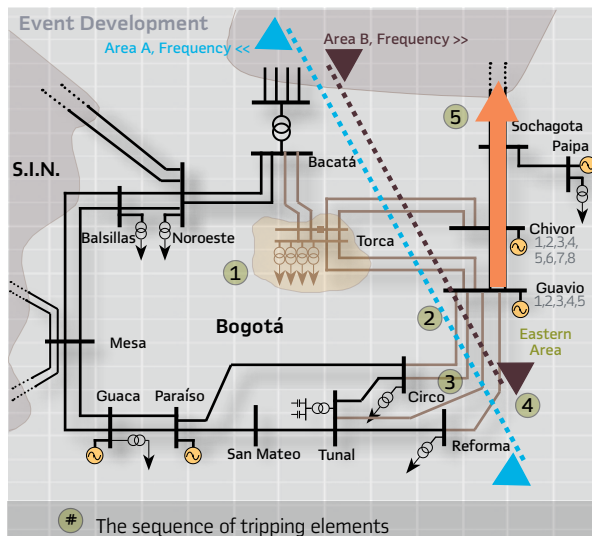
2 Substations around Bogota

affecting the frequency. As a consequence of the outage at the Torca substation, six power lines and three 230/115KV transformers were shut down, and a sequence of events took place: Firstly, the lines Guavio-Circo were overloaded and tripped. Secondly, the outage of these lines (Figure 2) caused a reduction in voltage and overload conditions in some regions.

The only remaining links (*Guavio-Tunal and Guavio-Reforma-Tunal*) became overloaded, so frequency and bus voltages collapsed beyond the safe limits, thus causing the islanding of this area from the rest of the interconnected system with the opening of the lines Guavio-Tunal and Tunal-Reforma.

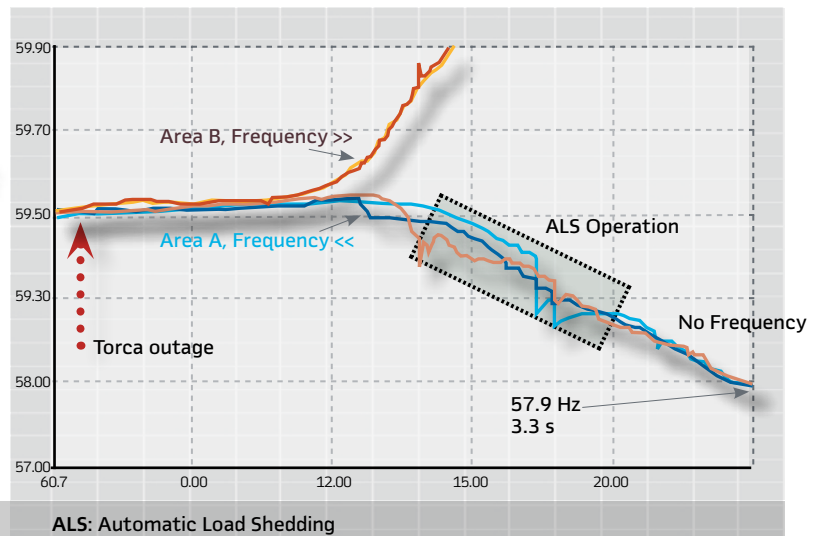
3 Frequency during the contingency

With the partition of the CEPS into two areas, A and B (*Boyaca and Santander regions*), there was a deficit of power in area A which collapsed the frequency in this area and a power surplus in area B which created an over-frequency situation in area B. The evolution of the frequency in the areas A and B during the contingency is shown in Figure 3.

The severity of the contingency didn't give the ALS a chance to compensate the power unbalance in area A. The ALS worked as it was designed to work, but it had to work under an unexpected contingency and could not control the drop in frequency.

Figure 3 shows the interval where the ALS worked (see the box highlighted in blue). Colombia was then isolated from Ecuador's electric power system, and all the power plants
