# MAJOR DISTURBANCE IN UCTE system

The Union for the Coordination of Transmission of Electricity (UCTE) grid suffered a severe disturbance on 4 November 2006. Immediate action by TSOs prevented a Europe-wide blackout. This article summarizes the findings <http://www.ucte.org> from the subsequent UCTE investigation.

## Tokyo Blackout August 14, 2006

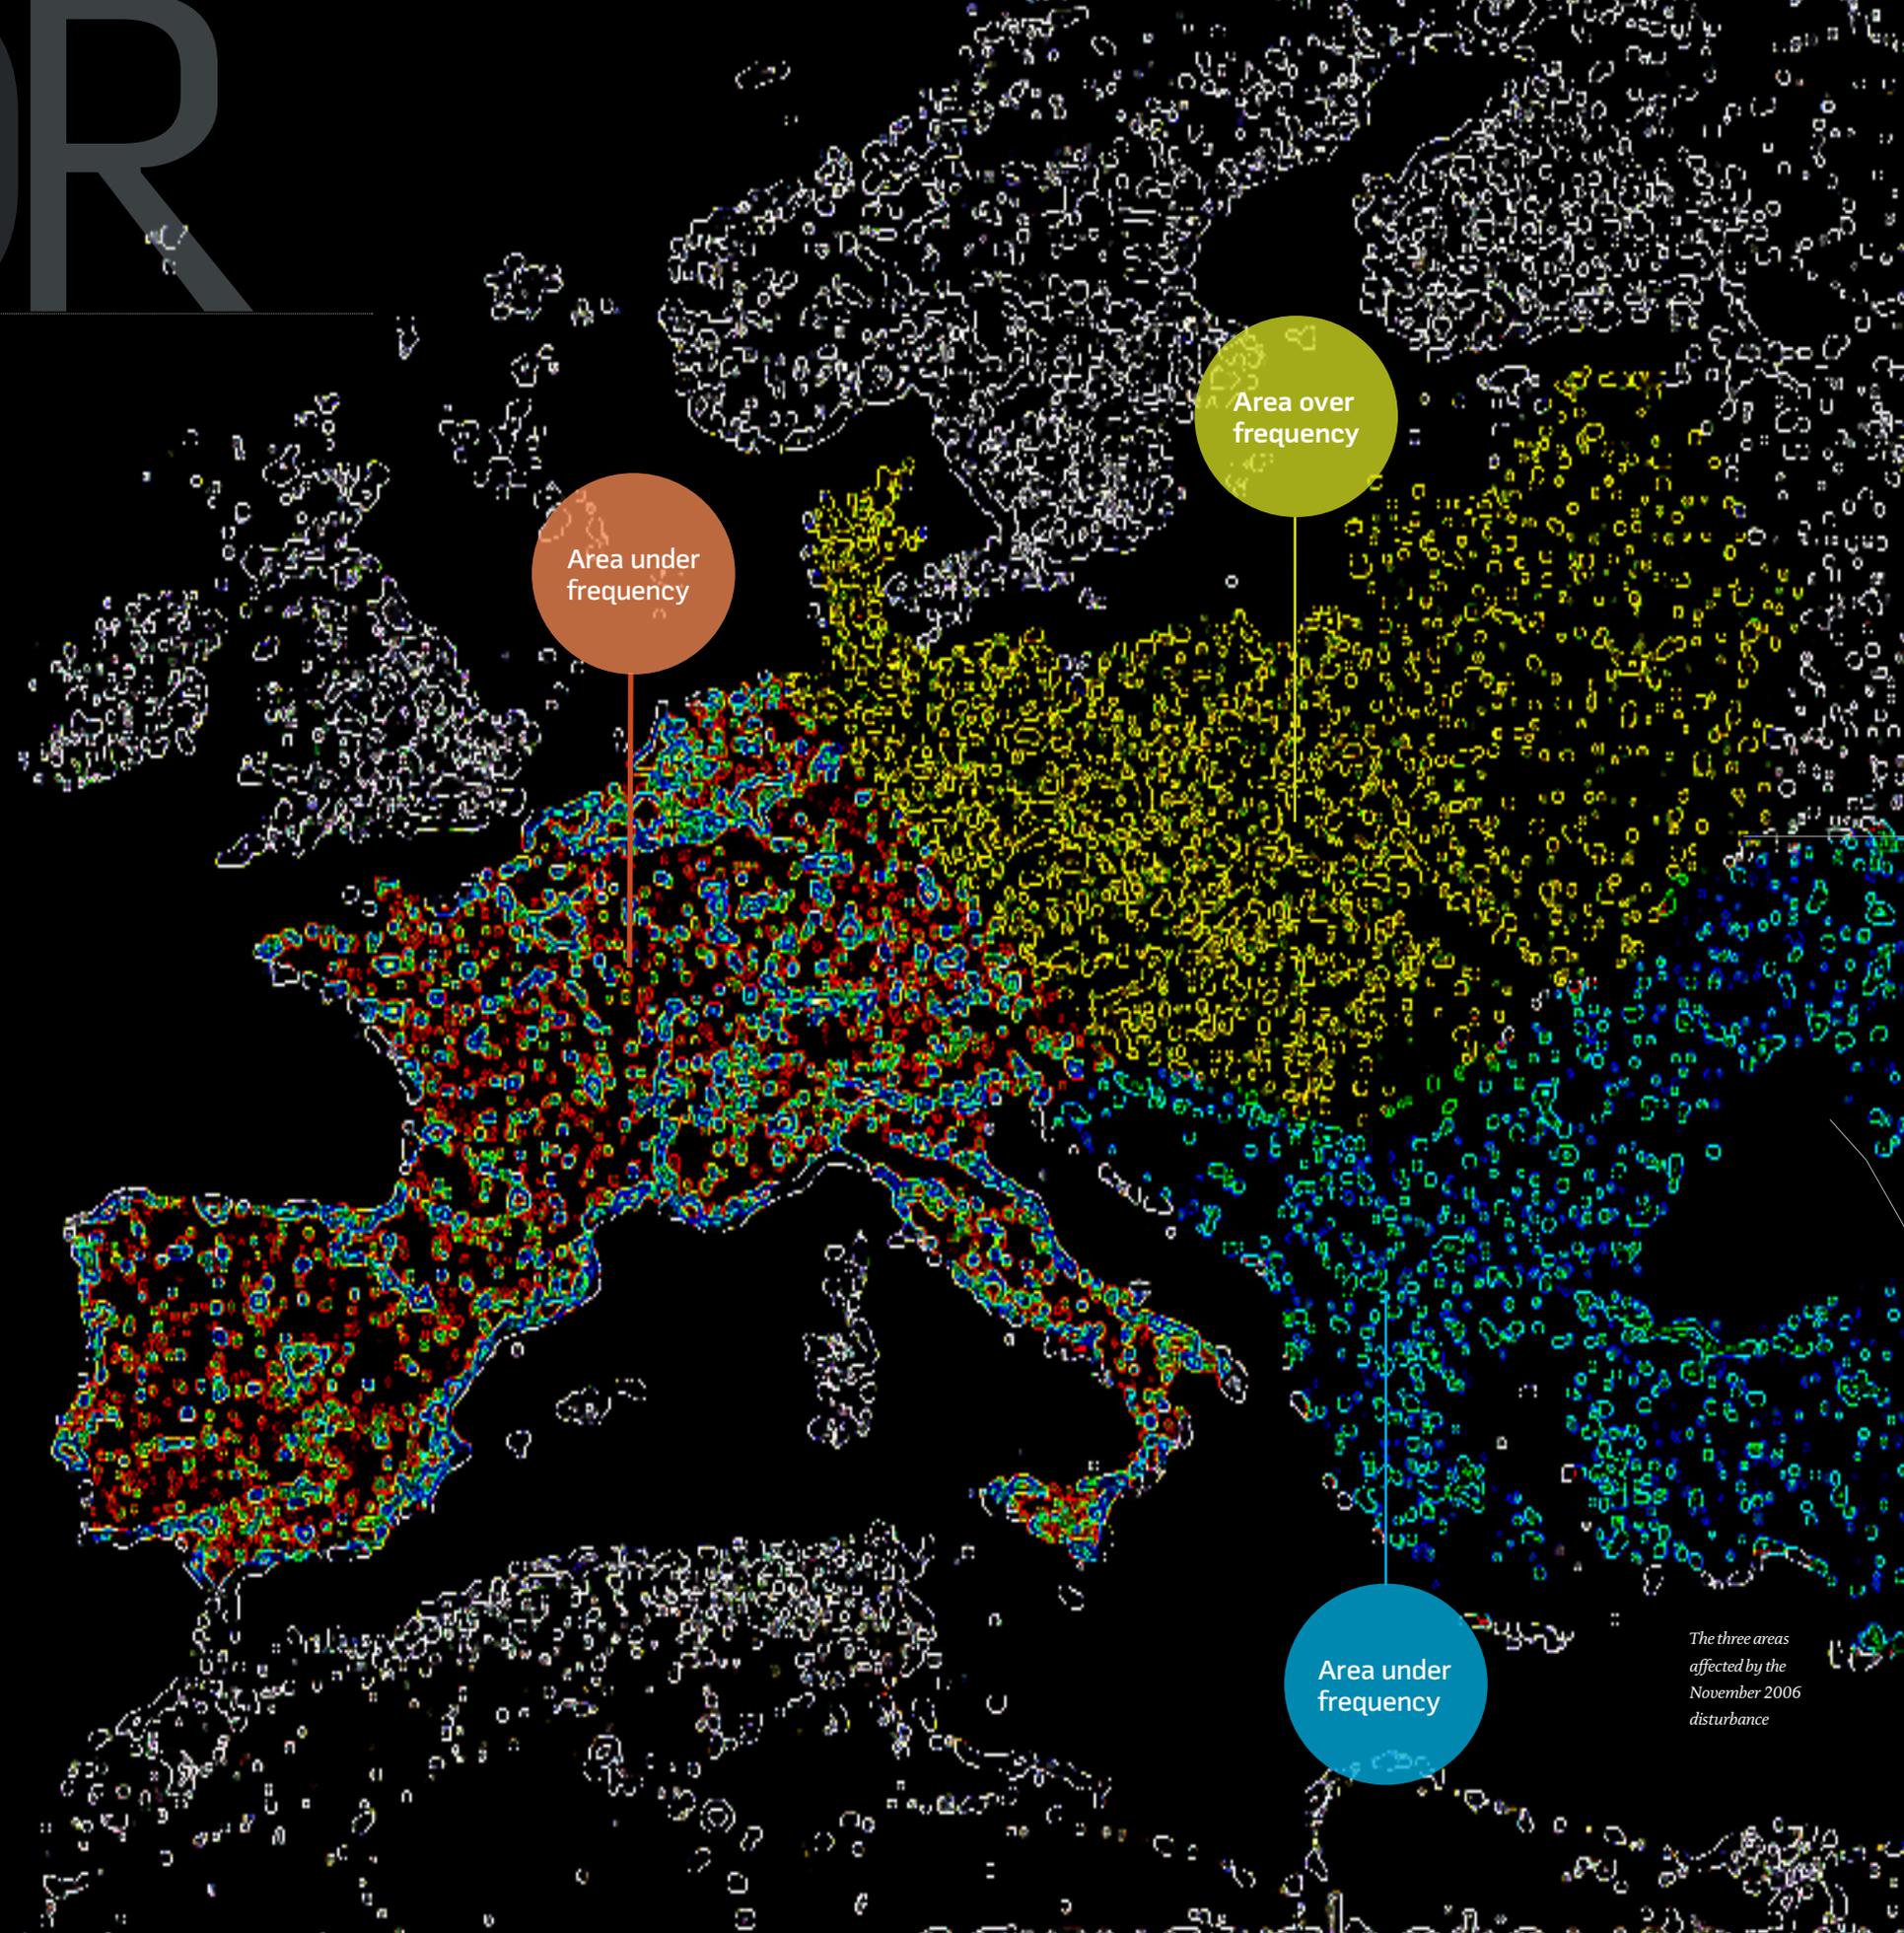
*The three areas  
affected by the  
November 2006  
disturbance*

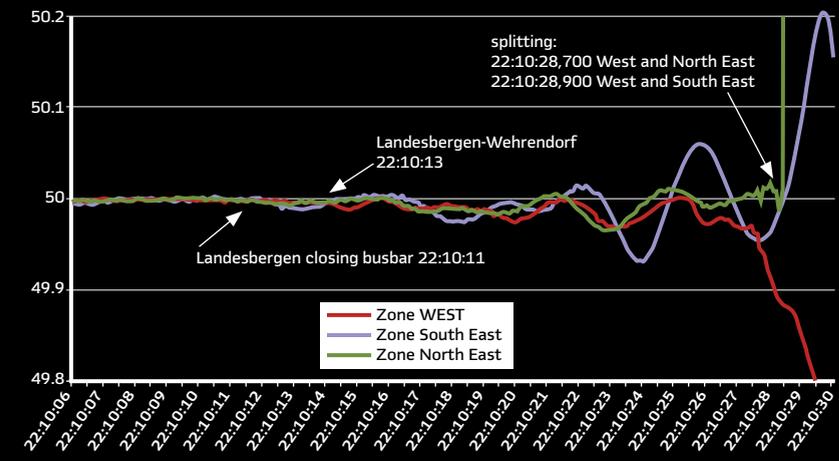
1 Frequency recording until area splitting

**22:08** RWE TSO requested E.ON Netz to intervene to restore safe grid operation. E.ON Netz's empirical assessment of corrective switching measures suggested that coupling the busbars in Landesbergen substation would reduce current. They initiated this switching at 22:10 without coordination with RWE TSO. Contrary to expectations the line current increased. Wehrendorf substation (RWE TSO) protection tripped and triggered cascade tripping all over the UCTE area. UCTE Separation The UCTE system split into 3 areas at **22:10:28**. The interconnection between Morocco and Spain tripped on low frequency at **22:10:32**. Figure 1 shows the frequency in the 3 areas from **22:10:06 to 22:10:30**. Time stamps of key events are

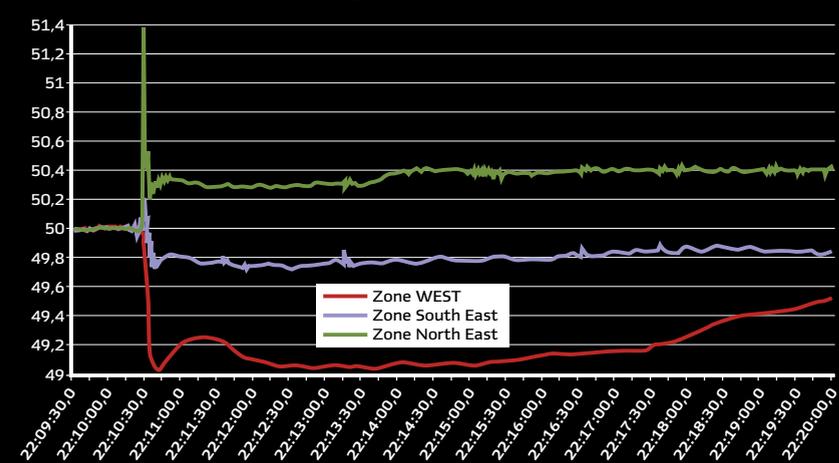
2 Frequency recording after the split

indicated. Figure 2 shows the frequency for the 3 islands from **22:09:30 to 22:20:00**. The split caused a power imbalance by cutting 9,500MW power transfer from the East to the Western area which induced a frequency drop to 49Hz in the West. The corresponding power surplus in the North East increased the frequency to 51.4Hz. The split caused an 800MW power deficit in the South East area inducing under-frequency of 49.7Hz. Resynchronization A number of resynchronization attempts took place, however the first successful reconnection between the West and North-East areas was completed at **22:47:11** on the 380kV Bechterdissen-Elsen line. The resynchronization was completed when the last 400kV line between Croatia and Hungary was switched in at **22:57**.

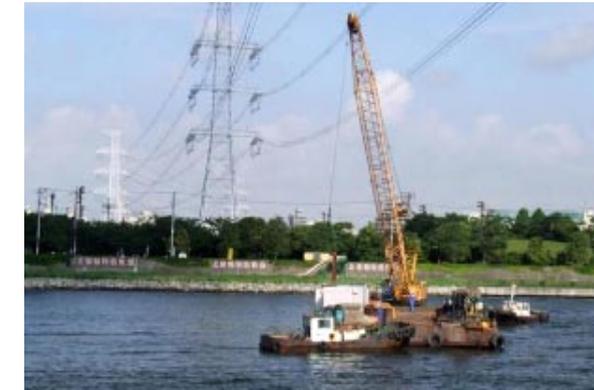
The second largest blackout in the history of TEPCO (The Tokyo Electric Power Company, Inc.) hit central Tokyo area at about 7:38 a.m. on August 14, 2006. It was caused by a **floating crane** on a barge going upstream on a river on the eastern edge of the city.

THE WORKERS ON THE BOAT DID NOT realize that the 33 meter crane was raised too high, so it hit TEPCO's 275 kV double circuit transmission lines that run across the river.

Floating crane that initiated the blackout

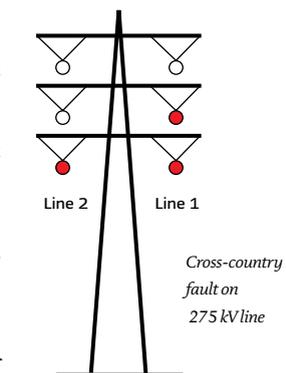
As a result of the accident the transmission lines were short-circuited and the wires damaged. The relay protection operated and tripped both lines. Power transmission was interrupted, resulting in a blackout that affected about 1.4 million households and offices during a very hot summer day. The transport network was disrupted, with passengers unable to use two lines on the city's largest subway operator, Tokyo Metro, for an hour to 90 minutes. There were no reports of injuries. The affected areas included the central part of Tokyo, northern part of Yokohama and western part of Kawasaki in Kanagawa, Ichikawa and part of Urayasu in Chiba. TEPCO immediately started trying to restore power supply to its customers. A Power Station continued to supply power until 7:58 a.m. after successful operation of a System Integration Scheme for the islanding, when it was automatically shut down because the balance between the generation and load was lost due to increased demand in the morning. About 174,000 households and offices were blacked out as a result. 59 minutes after the initial event, at 8:37 a.m., all substations were restored and resumed power transmission. Electricity supply to all TEPCO customers, except for two high-voltage customers, was

Damaged conductors
