by Janusz W. Dzieduszko, Quanta Technology, USA

# Substation "Horror Stories" - a Manufacturer's Perspective

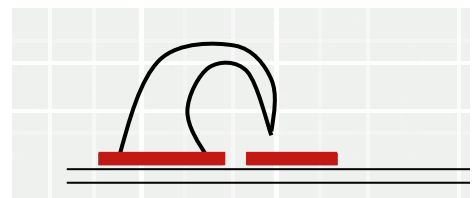
### 4 Solder whisker

During the field trip to the substation, the real problem was determined to be a solder whisker on a printed circuit board extending to the adjacent trace, as shown in Figure 4.

During abnormal system behavior with the RTU enclosure sealed, the internal temperature caused the solder whisker to expand, touching the adjacent PCB trace and disabling the alarm acknowledge circuit. Opening the enclosure to swap TX and RX relays lowered the temperature sufficiently to contract the whisker, thereby "fixing" the problem.

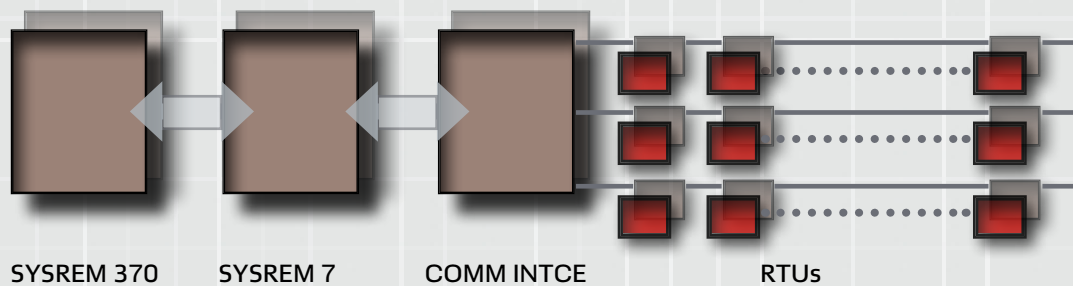
## 6 Process control system

A large process control system as shown on the diagram in Figure 6 was installed. A major computer manufacturer provided main control processors, SYSTEM 370 and SYSTEM 7 and software; COMM INTFCE and RTUs were supplied by (then) a Major SCADA Company. RTU communication was via copper shielded twisted pairs with a maximum distance of 5 km. Asynchronous frequency shift (FSK) modems operating at 1800 bps, with mark and space frequencies of 1200 and 2200 Hz respectively, were used. Connection was 4 wire with separate pairs for data transmit and receive. RTU communication used popular 32-bit protocol with 2 start, 24 data, 5 CRC and 1 stop bits. SYSTEM 7 to COMM INTFCE data link was parallel with 12 bit data lines and several control lines.

*During final system start-up, a vicious communication problem was uncovered.*

Several (2 to 4) times per day COMM INTFCE reported CRC (cyclic redundancy check) errors on data acquisition; this condition existed in short bursts of 120 to 180 msec.

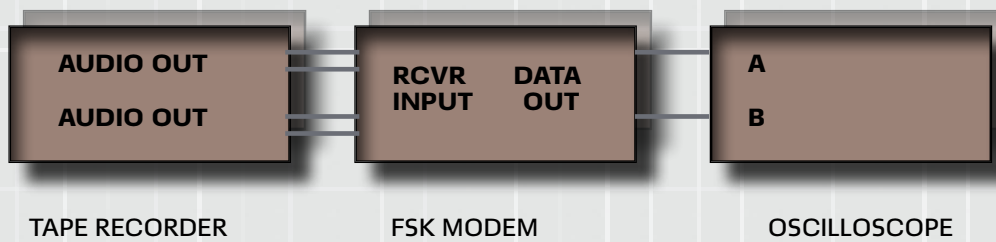
## 7 Error sections of tape playback

the tape counter on tape recorder. Known sections of tape were played back as in Figure 7. Normal data retrieval sequence consisted of one 32 bit request sent to RTU, followed by up to 8 32 bit responses from RTU.

It was determined that during the communication problems one 32-bit data request was repeated as shown:

The “phantom” request, shown as shaded area, was later attributed to the race condition on the COMM INTFCE parallel to serial converter when “write” signal exceeded maximum allowable duration.

As a result the receiver clock recovery mechanism was disabled and the incoming RTU response was received using transmit clock! No wonder massive CRC errors were encountered. It was later determined that the duration of

“write” signal was affected by SYSTEM 7 loading. To make COMM INTFCE immune to variations of this signal, a monostable multivibrator (one shot) was added, thus eliminating the entire problem.
