PRIMARY RELAYING SYSTEM FAILURES are associated with long fault durations because backup relaying must be relied upon to clear the fault. A slow trip and the accompanying long-duration voltage dips can be very costly to sensitive customers, such as semiconductor manufacturers, due to product loss. An even worse scenario would be to unnecessarily trip one of these sensitive customers and completely put them in the dark.

DFRs are powerful tools to use when analyzing system operations, but they are only as good as the information being fed to them. Sometimes they contain very valuable “hidden” information that can easily be missed at first glance. The rest of this article describes the process through which Oncor Electric Delivery went to get to the bottom of a relaying system failure, and find the true root cause.

RELAY SYSTEM FAILURE #1

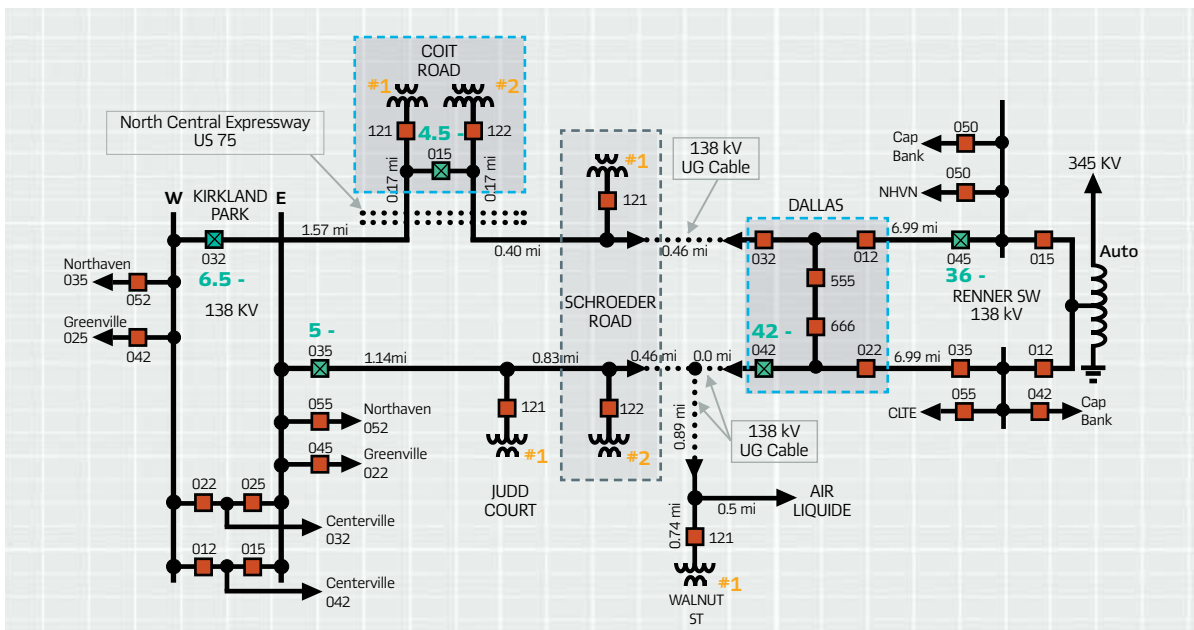
2 System Configuration After Fault was Cleared

Dallas is being served by a single 138kV line from Renner CB 035

(ground time-overcurrent flags). At this point, Dallas was being served by a single 138kV line from Renner CB 035 (Figure 2). This configuration continued for 4 seconds until Renner CB045 reclosed.

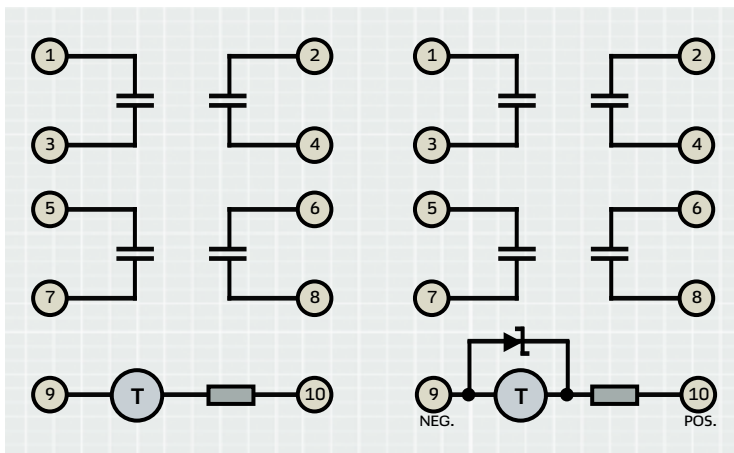
5 Correct and 6 Incorrect Schematic

that is used to key the transmitter. The diode caused the relay coil to be shorted out and never pickup even though voltage was applied. The nameplate Style # and Internal Schematic # attached to the high speed auxiliary tripping relay did not call for a diode. Relays with a diode are a completely different Style # and Internal Schematic #, so it is still unknown as to how the relay was mislabeled or if it was modified in the field. The correct relay schematic is shown in Figure 5.

Polarity of the coil does not matter for this style of relay. Figure 6 shows the incorrect relay schematic that corresponds to what was actually installed at Kirkland Park CB 035. It is crucial to have the correct polarity for this style of high speed auxiliary tripping relay. Figure 8 shows the diode across the relay coil found at Kirkland Park CB 035.

The relay (85/XX) was wired according to the print (shown in Figure 7), which calls for terminal 9 to be positive and terminal 10 to be negative. This caused the coil of the relay to be shorted out by the parallel diode. If the coil polarity had been reversed as it is required for that style of relay, then the POTT scheme would have operated correctly.

according to style number as-found in the field

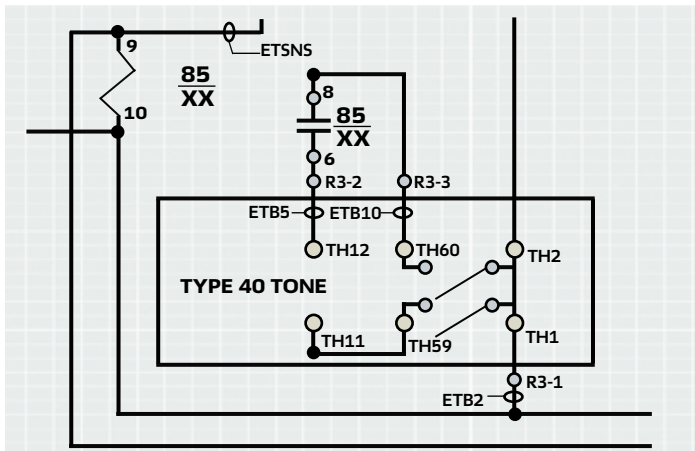
7 Kirkland Park CB035

Keying Circuit

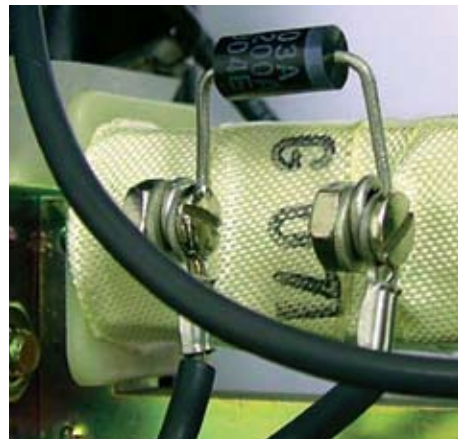
8 Kirkland Park CB035

It was found that Kirkland Park CB 035 failed to send a trip permissive to Dallas CB 042 because of a diode across the operate coil of a high speed auxiliary tripping relay

The root cause of the failure to send a trip permissive is improper functional testing during checkout.

Relay, close-up of diode across relay coil

The remedy for this problem was very straightforward – **replace the “bad” high speed auxiliary tripping relay and perform a full functional test.**
