by Yujie I. Lu and Jeffrey Pond, National Grid, USA

Analysis of Simultaneous Faults Using Short Circuit Simulations and Fault Records

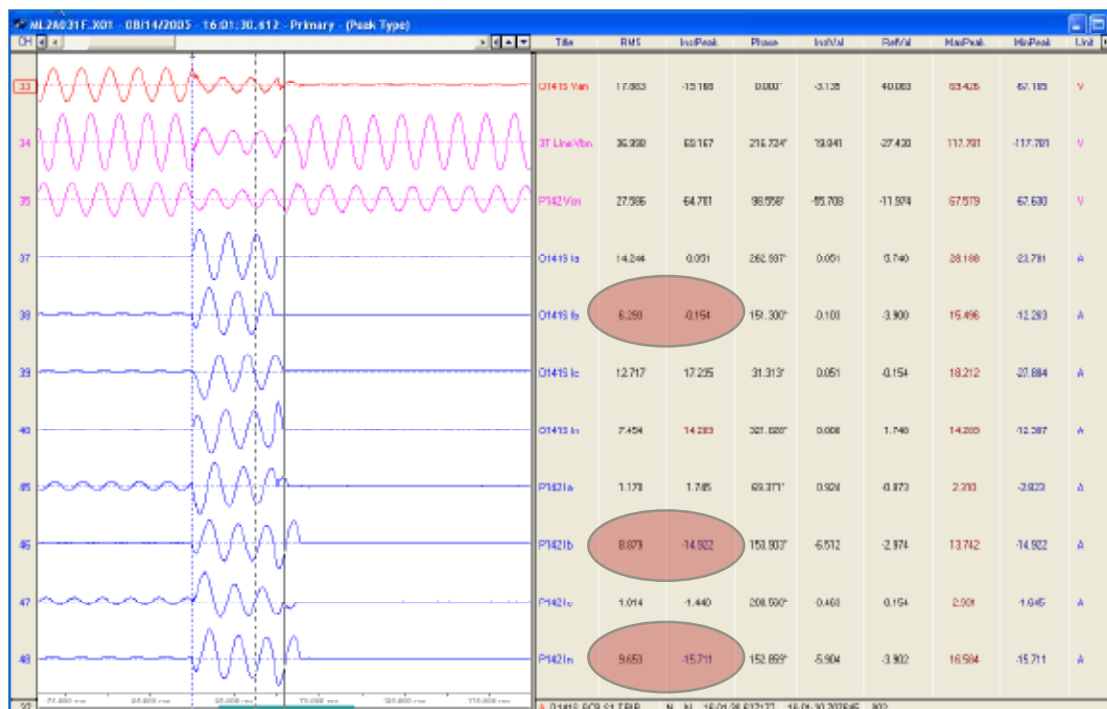
1 O-141S and P-142S Line DFR Records at Millbury #302

Knowing the construction of these lines, it was believed that it would have had to have been a high current stroke to trip both lines. Next, the sequence-of-event and digital fault recorder (DFR) records captured at Millbury #302 were collected, which indicated that the fault occurred on both O141S and P142S lines at 3.06 miles from Millbury #302. Based on the records, the fault involved A-phase-, B-phase- and C-phase-to-ground on the O141S line and B-phase-to-ground on the P142S line with fault impedance (Figure 1). It was then further noticed that:

■ The B-phase fault current flowed through the O141S and P142S from Millbury #302 were almost in phase, which implies that it was

indeed a simultaneous fault. At the cursor (or trigger) point of Figure 1, Ib-O141S was 6.29 @ 151.30 and Ib-P142S was 8.88 @ 153.90 in secondary amperes.

■ The B-phase and the ground (the zero-sequence current, 3I0) fault current flowed on P142S from Millbury #302 were in phase, which implies that the fault on the P142S was B-phase-to-ground. At the cursor (or trigger) point of Figure 1, Ib-P142S was 8.88 @ 153.90 and 3I0P-142S was 9.65 @ 152.90 in secondary amperes.

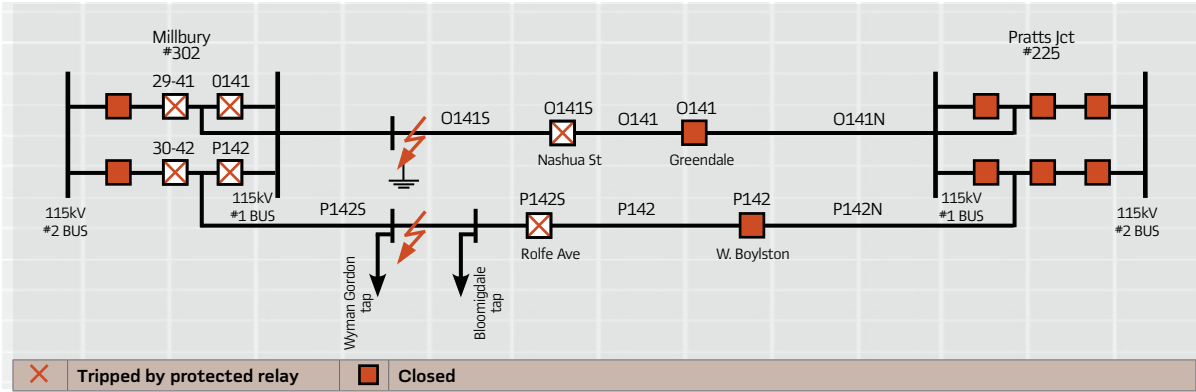
2 One line diagram for O-141 & P-142 lines

Case One:
On August 14th, 2005, the National Grid System Control Center reported that at 16:01:30 a lightning stroke caused a fault on the 115kV O-141S line near the company's Millbury #302 substation. The substation and faulted line configuration are shown in Figure 2. The circuit breakers O141 and 29-41 at Millbury #302 and O141S at Nashua St tripped correctly by the line protection relays. As per the report, at the time of the O141S operation, the 115kV P142S line, one of the parallel lines with the faulted O141S line, tripped by their line protection relays at Millbury #302 and Rolfe Avenue substations for the O141S fault. Targets reported for these two operations are shown in table 1.

Why did the P142S line relays respond to the O141S fault? Was it a single circuit fault only? First, the investigation team verified that both lines share double-circuit towers with a vertical design between

Millbury #302 and Rolfe Avenue, where the P142S line is more highly insulated than the O141S line. The conductor phasing arrangements, top to bottom, are B-C-A on the O141S and A-B-C on the P142S.

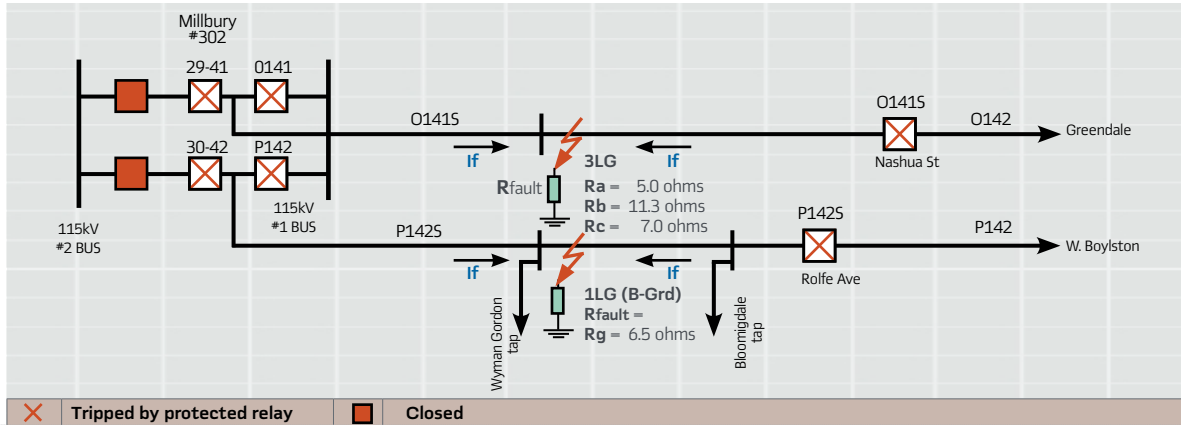
3 O-141S & P-142S line fault

- The fault did involve A-, B- and C-phase on the O141S lines and B-phase-to-ground on the P-142S line simultaneously, and

- It was a non-bolted fault with phase-to-phase and B-phase-to-ground resistance involved on the O141S and P142S line, respectively.

Finally, the results concluded that the fault resistance for the O141S three-phase-to-ground fault was approximately as follows: $R_a = 5.0$ primary-ohms, $R_b = 11.3$ primary-ohms and $R_c = 7.0$ primary-ohms, and the fault resistance for the P142S B-phase-to-ground fault, R_g , was around 6.5 primary-ohms. (Figure 3 & Table 2)

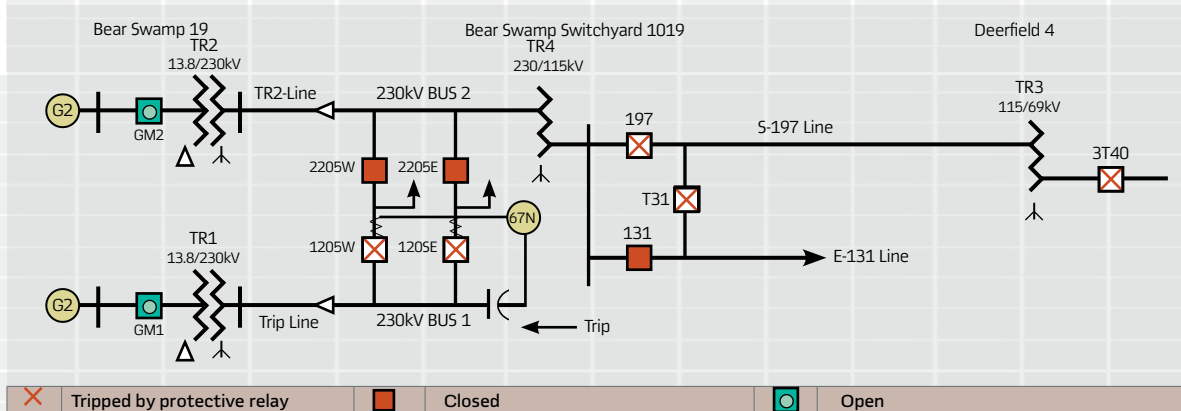
4 S-197 One line diagram

On May 27, 2007 the System Control Center reported that at 23:33:32 a large oak tree fell on the S197 Line at Brittingham Hill Road near Tower 126 during a thunderstorm. At Bear Swamp 1019 the 197 and T31 circuit breakers (CBs) tripped, and at Deerfield 4 the 3T40 CB tripped (figure 4). At 23:33:33 the 1205W and 1205E CBs opened. At 23:33:37 the 197 CB closed auto and tripped immediately. All breakers were locked out. See table 3 for the reported targets for this disturbance. (Figure 4)

The S197 Line fault was confirmed when the tree was found on the line. However, there was no evidence of a fault on the TR1 Line. The TR1 Line operation was a suspected improper operation of the directional ground (67N) protective relay. Was this an improper operation or a separate incident? Prior to the start of the investigation it was confirmed that the power system was operating normally prior to the fault and the generators at Bear Swamp 19, which is a pump storage facility, were off-line. The initial analysis using the one-line diagram in figure 4 agreed with the theory that the TR1 Line protection did mis-operate for the line fault because the faults were behind the protected zone of the TR1 directional ground relay. However, the Control Center report stated that the 1205W and 1205E tripped after the 197 and T31 CBs and before the 197 CB auto-closed suggesting this may be a separate event. The next phase of the analysis was to

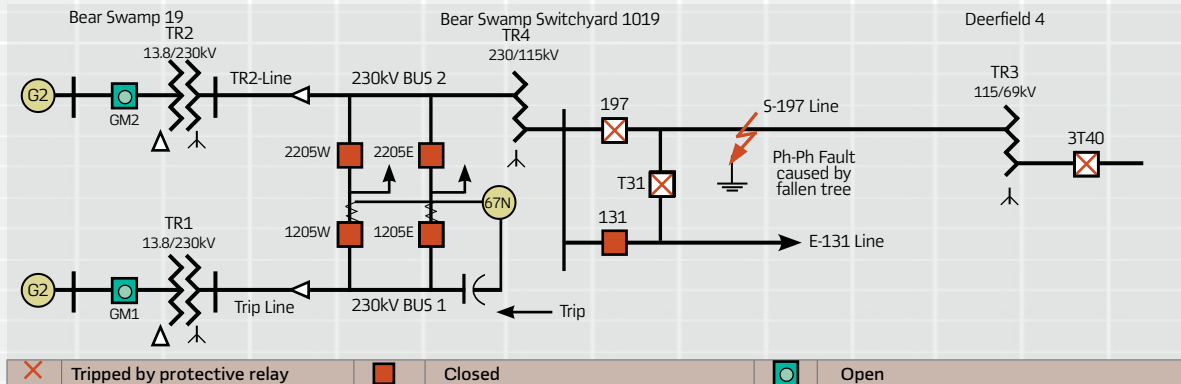
5 S-197 Line One-Line Diagram – Initial Fault

Analysis of the fault records determined the initial fault occurred at 23:33:29.610 when the tree fell on the S197 Line causing a B-C-phase fault. The 197 and T31 CBs at Bear Swamp and the 3T40 CB at Deerfield 4 tripped on DD Z1 S1 (figure 5). It was determined that the TR1 Line protection did not operate for the first S197 fault or immediately after.

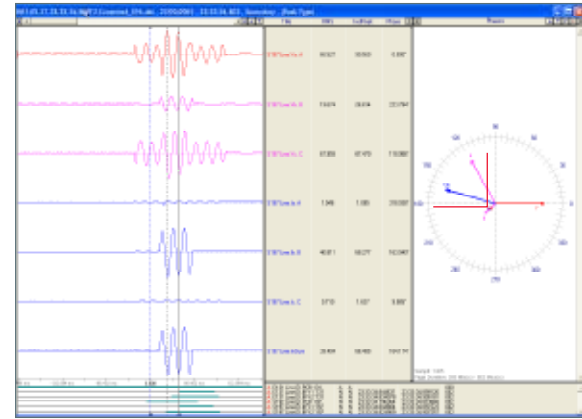
6 197 CB Auto-Close into B Ph – Gnd Fault at 23:33:34.802

The fault record triggered at 23:33:34.802 shows the 197 CB auto closed, after five seconds, into a B-G fault, caused when a transmission tower was damaged as a result of the fallen tree, and tripped immediately (figure 6 & 8) on S197 IOC B-ph. At the same time the TR1 Line DG relay operated initiating transfer trip to the Bear Swamp Powerhouse, and tripped the 1205E and 1205W CBs (figure 7 & 8). The S197 and TR1 Line

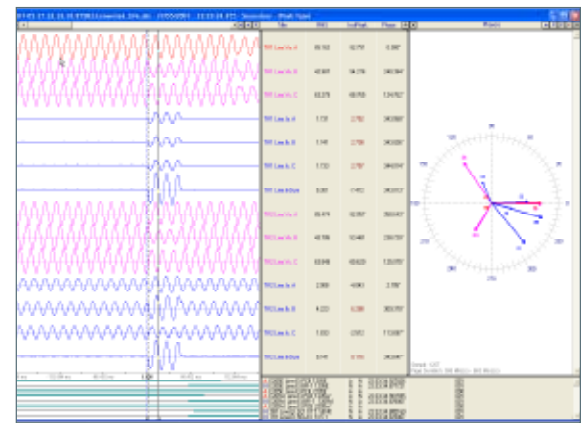
7 TR1 & TR2 Line Waveforms Second Fault at 23:33:34.802

fault through the Generator 1 GSU at Bear Swamp 19 as was determined from the fault record (figure 7). Based on the analysis the TR1 Line DG relay operation was determined to be a correct operation even though the two faults were behind the relay.

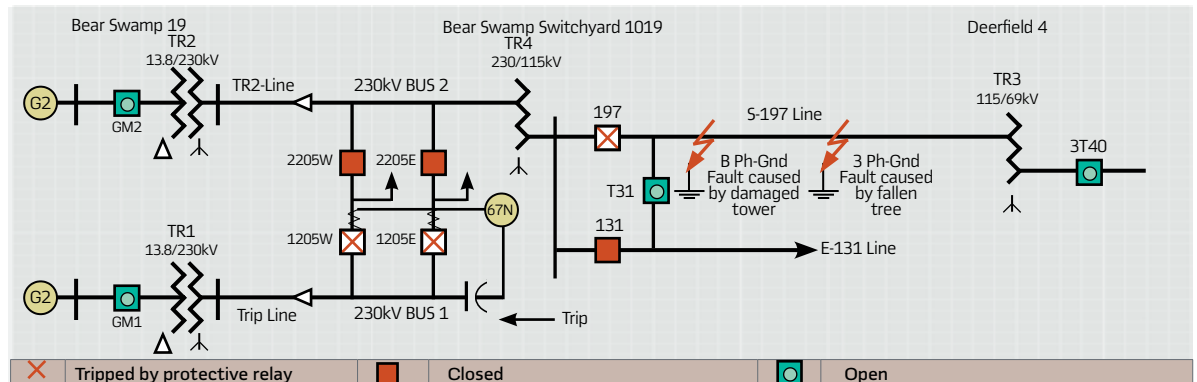
8 S-197 Line One-Line Diagram – Simultaneous Fault

Based on the analysis it was determined that for the initial fault the S197 Line directional distance protection operated properly at both Bear Swamp Switchyard and Deerfield 4 for the B- to C-phase fault caused by the falling tree. After the initial phase to phase fault the tree came to rest across all three phases of the S197 line creating a permanent three-phase to ground fault and causing damage to Tower 126 which is lattice steel construction. As a result of the damage caused by tree falling on the line a permanent B-phase to ground fault was

created on the S197 Line at tower 126. When the 197 CB closed auto in five seconds the B-phase to ground fault, caused by the damaged tower, was supplied by the S197 line at Bear Swamp. The TR1 Line supplied zero-sequence current to the three-phase to ground

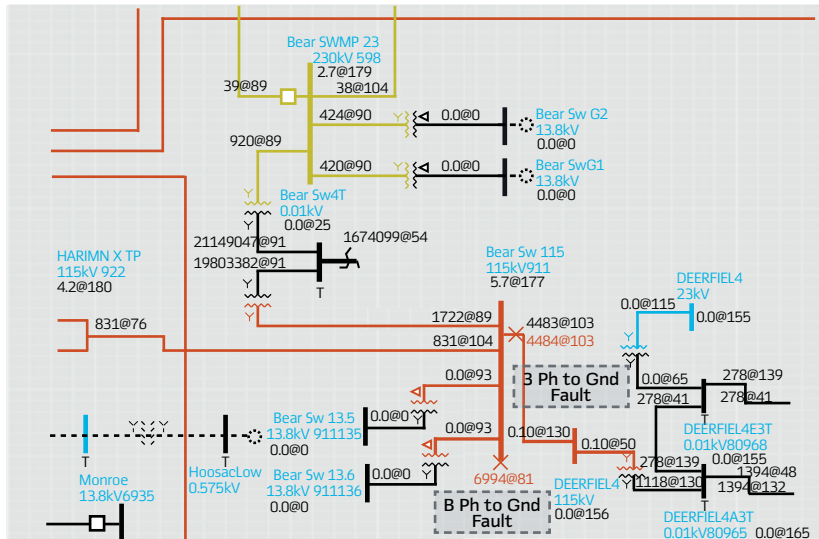
9 Short Simulation Fault Locations

was accurate. The simultaneous fault module would not allow placing two faults on the same line segment, therefore, it was decided that in order to create the simultaneous fault in the short circuit model first, a phase to ground fault was placed on the 115kV Bus at Bear Swamp because tower 126 where the B-phase to ground fault occurred was approximately one mile from the Bear Swamp Switchyard. Second, a three phase to ground fault was placed on the S197 Line near Bear Swamp (figure 9). The simulation confirmed that the Directional Ground relay, which is a Westinghouse IRQ-9 with negative sequence polarizing, had sufficient polarizing volt-amperes in the forward direction and neutral current to operate. As a final check the TR1 line negative sequence quantities were calculated from the fault records to be 2.88VA, well above the 0.76 VA minimum pick-up of the relays directional unit, and the phasors were compared to the IRQ directional unit characteristic. As can be seen in figure 10 the calculated negative-sequence components are similar and match the relay characteristic.
