by Janusz W. Dzieduszko, Quanta Technology, USA

# Substation "Horror Stories" - a Manufacturer's Perspective

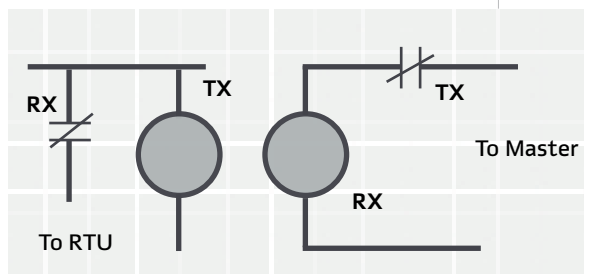
## 2 60 mA Loop

The equipment and location were the same as in the previous episode. Under normal operating conditions the alarm or change of contact status was reported by an RTU and acknowledged by a Master Station to reset the alarm. The communication links to the RTUs were 60mA loops operating at 50 bps (sic!) connected as shown in Figure 2. The transmit TX and receive RX devices were identical mercury wetted contact relays with plug-in octal bases.

One of the RTUs reported an alarm but the Master Station acknowledgement failed to reset it, and thus an alarm condition persisted at the RTU. The system operator would dispatch a technician to the RTU who subsequently swapped TX and RX relays, thereby eliminating the problem.

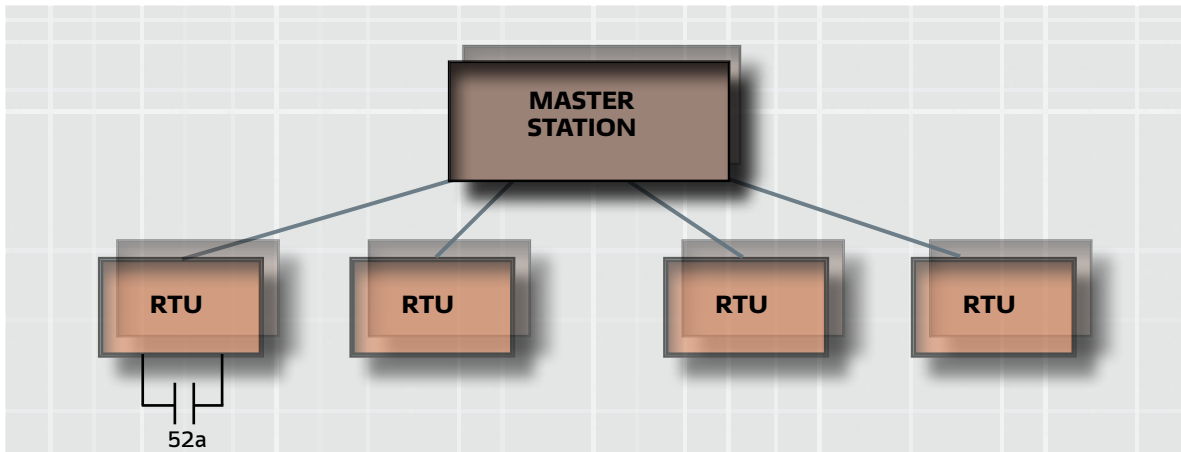
## 5 Typical SCADA configuration

A Supervisory Control (early 1970's predecessor of SCADA) system at a major Electric Utility reported circuit breaker operations at several substations occurring at random, over the span of several weeks.

Subsequent inspection of the breaker control equipment at those substations revealed that no breaker operations took place and a Supervisory Control equipment was providing false information. Several dozens of these systems were purchased and installed by that Utility. Naturally, the reliability of the equipment and the qualifications of the personnel involved in its design and manufacturing were seriously challenged by the Utility management.

As the week came to a close, the 52a wiring (see above) check was done in desperation. The RTU terminals looked fine; however, a walk to the breaker control box in the

yard was very fruitful; the corresponding terminals had loose screw connections! It was discovered later that the same problem existed at all suspected RTU locations. End result: happy Customer!
