PRIMARY RELAYING SYSTEM FAILURES are associated with long fault durations because backup relaying must be relied upon to clear the fault. A slow trip and the accompanying long-duration voltage dips can be very costly to sensitive customers, such as semiconductor manufacturers, due to product loss. An even worse scenario would be to unnecessarily trip one of these sensitive customers and completely put them in the dark.

DFRs are powerful tools to use when analyzing system operations, but they are only as good as the information being fed to them. Sometimes they contain very valuable “hidden” information that can easily be missed at first glance. The rest of this article describes the process through which Oncor Electric Delivery went to get to the bottom of a relaying system failure, and find the true root cause.

RELAY SYSTEM FAILURE #1

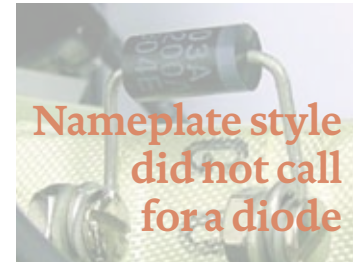
It was found that Kirkland Park CB 035 failed to send a trip permissive to Dallas CB 042 because of a diode across the operate coil of a high speed auxiliary tripping relay

that is used to key the transmitter. The diode caused the relay coil to be shorted out and never pickup even though voltage was applied. The nameplate Style # and Internal Schematic # attached to the high speed auxiliary tripping relay did not call for a diode. Relays with a diode are a completely different Style # and Internal Schematic #, so it is still unknown as to how the relay was mislabeled or if it was modified in the field. The correct relay schematic is shown in Figure 5.

Polarity of the coil does not matter for this style of relay. Figure 6 shows the incorrect relay schematic that corresponds to what was actually installed at Kirkland Park CB 035. It is crucial to have the correct polarity for this style of high speed auxiliary tripping relay. Figure 8 shows the diode across the relay coil found at Kirkland Park CB 035.

The relay (85/XX) was wired according to the print (shown in Figure 7), which calls for terminal 9 to be positive and terminal 10 to be negative. This caused the coil of the relay to be shorted out by the parallel diode. If the coil polarity had been reversed as it is required for that style of relay, then the POTT scheme would have operated correctly.

The root cause of the failure to send a trip permissive is improper functional testing during checkout.

The remedy for this problem was very straightforward – **replace the “bad” high speed auxiliary tripping relay and perform a full functional test.**
